**R00EJ**

February 16, 2001

## Recall R00EJ WABCO ECU Noncompliance Replacement Instructions

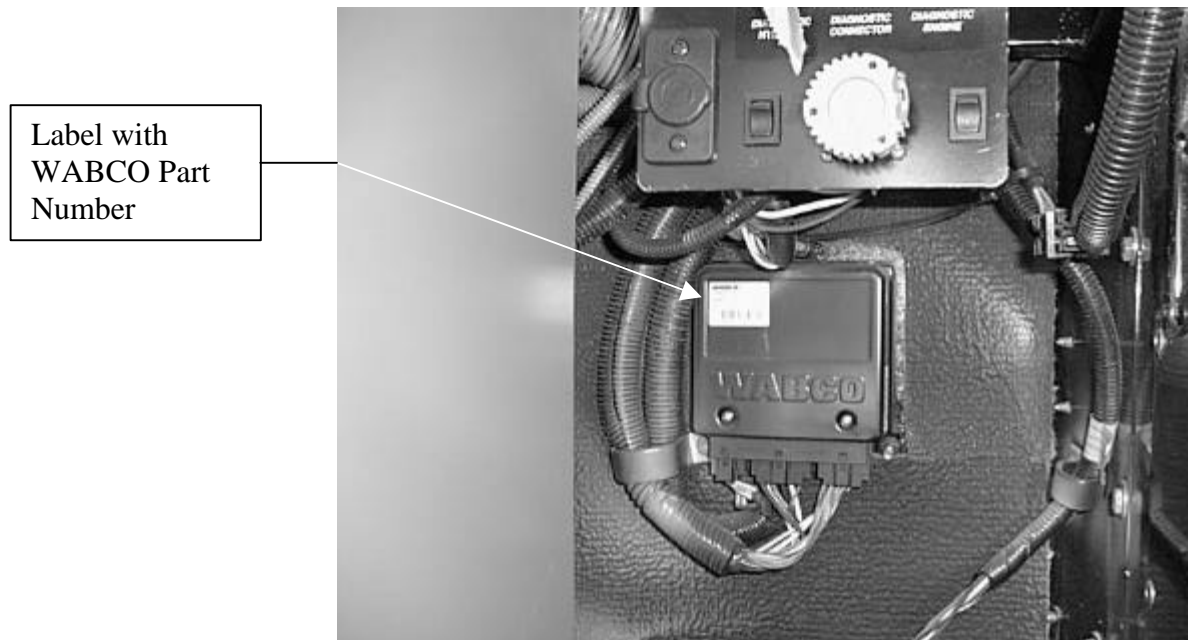
PHOTO 1

The WABCO ECU is located below the dash on the left inside front wall (see photo 1).

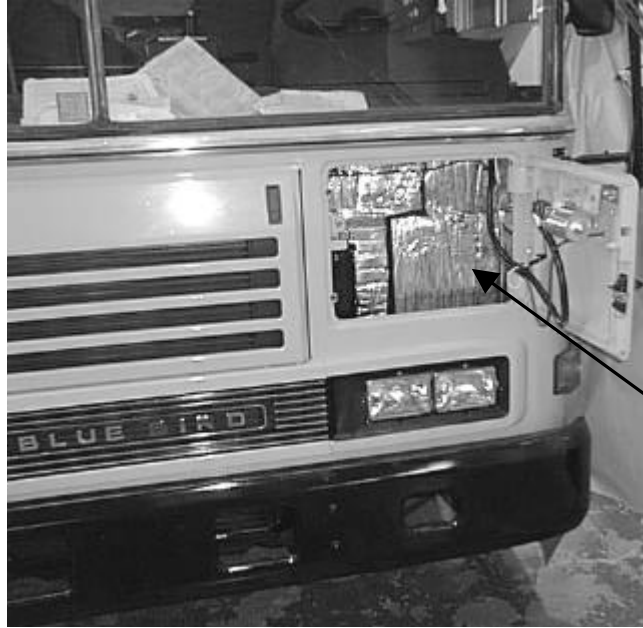
**PHOTO 2**

- 1 The WABCO ECU is located on the left outside front chassis outrigger behind left headlight (see photo 2).

- 2 Open left hand front windshield wiper access door. Remove the electrical access panel cover by turning latch knob counter clockwise (see Photo 2). From underneath the left front bumper, remove the electrical access panel (ECU behind panel) (see Photo 3) by removing four (4) 1/4-20 X 1" bolts, eight (8) flat washers, and four (4) 1/4-20 nuts.

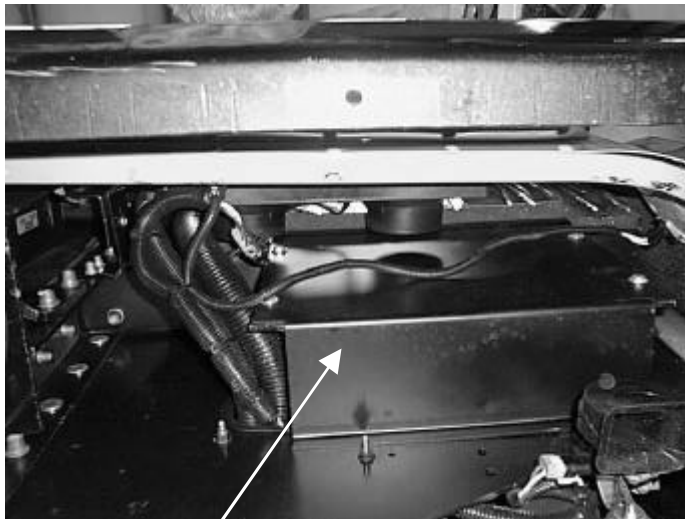
**PHOTO 3**

Electrical Access Panel

3. After the ECU inspection and/or replacement procedure has been completed, install the electrical access panel with the four (4) ¼” bolts, eight (8) flat washers and four (4) ¼” nuts remove in Step 2 above. Tighten to 5 FT.LB.
4. Install the electrical access panel cover and turn latch knob clockwise to latch and tighten against front structure.
