**R02GC**

The "Range Inhibited" indicator light for the Allison 2000 Series transmission was improperly installed and does not function on subject coaches. Blue Bird is conducting a recall to correct this defect.

## RECALL R02GC 'RANGE INHIBITED' LIGHT ACTIVATION INSTRUCTIONS

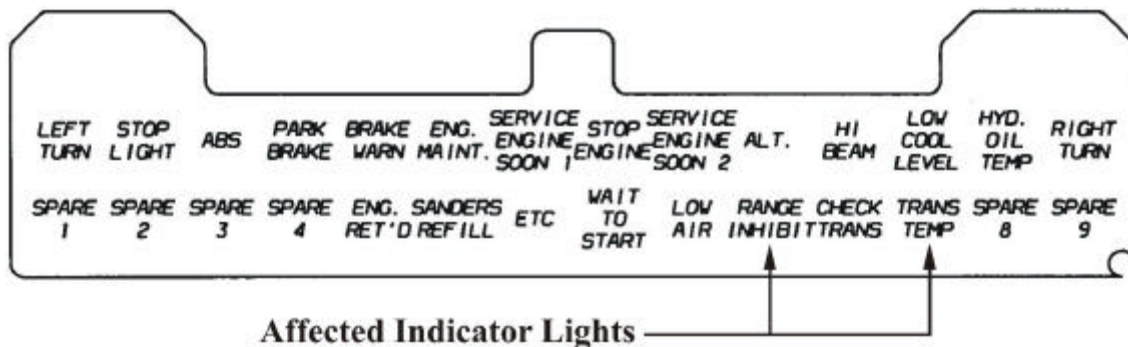
FIGURE 1

1. Park vehicle on level surface.
2. Apply parking brake.
3. You must first verify that the Allison 2000 Series transmission electronics (ECU) is sending a signal to the dash indicator lights by turning ignition on and off and seeing that the "TRANS TEMP" dash indicator light comes on for a few seconds and then goes off. The "RANGE INHIBIT" indicator light should not come on **AT THIS TIME**. The indicator lights are located on bottom of dash to right of center of dash. See Figure 1 below.

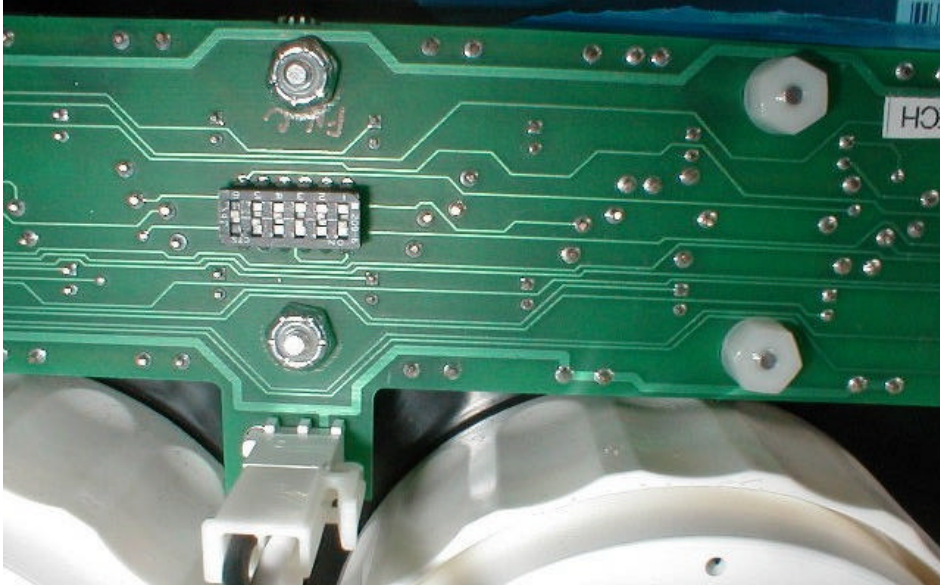
**Figure 2**

6. When sitting in the driver's seat and leaning over the dash panel, the dipswitch position 6 will be on your left and the dipswitch position 1 will be on your right. See Figure 2 below.

4. Remove the eight (8) Phillips head screws that secure the dash panel. Adjust tilt of steering column, if necessary, to gain access to screws.
5. Rotate top of dash panel towards you and lean over to view the 6-position dipswitch located on the back of the dash panel.
