R05JN

SUBJECT: RECALL R05JN INADVERTENT ENGINE SHUTDOWN

Inadvertent Engine Shutdown

MODELS AFFECTED: All Blue Bird Visions delivered through March 01, 2005

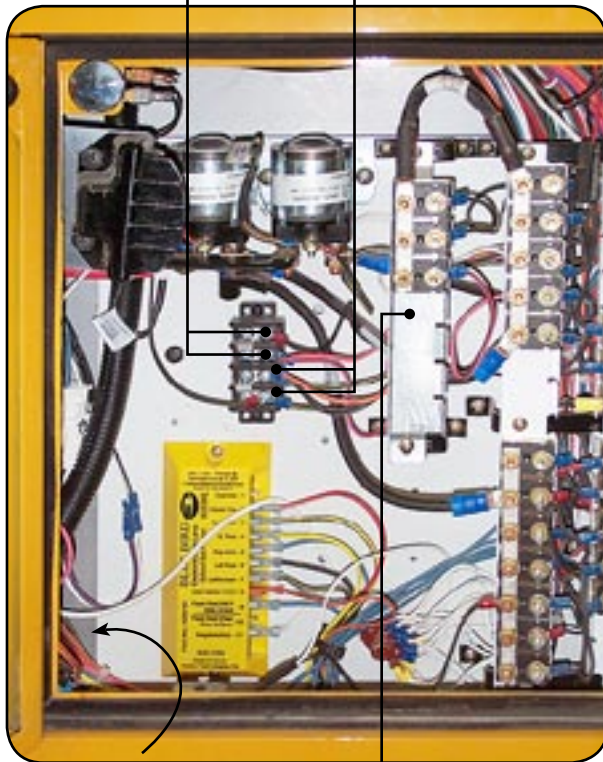
T/S 1 Terminal Block

The wire numbered 1168 will be entirely removed from the harness and discarded.

All other wires connected to these two terminals will be relocated to a new breaker.

The bottom two terminals of the Terminal Block will not be altered.

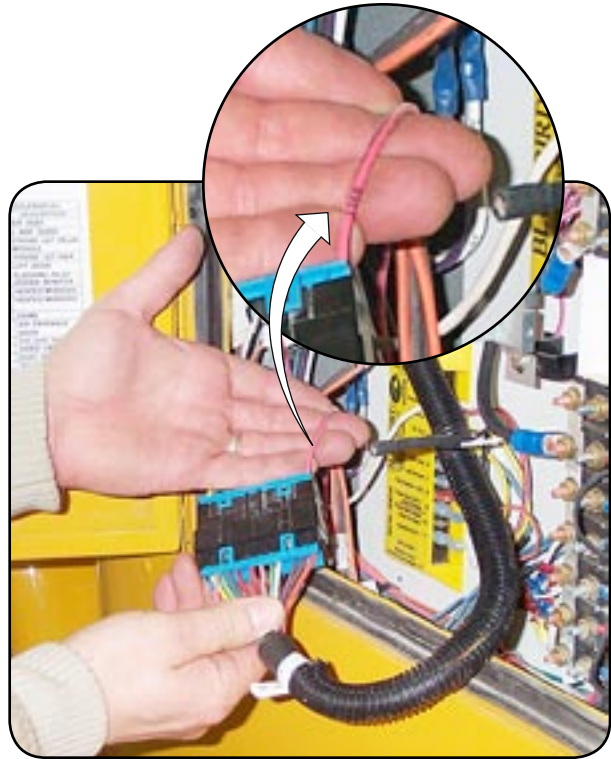
Circuit Breaker Bracket

The Body Harness Connector affected in this procedure is tucked behind the left bottom corner of the panel door post.

New breaker will be installed here, with relocated accessory wires attached.

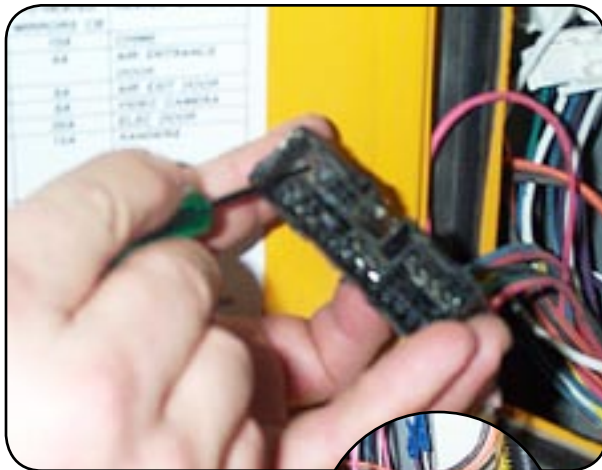
Wire 1168 removed from body harness connector.

3.3 Using a small screwdriver, mechanic's pick, or other suitable instrument, depress the internal clip which retains the 1168 wire's end terminal. Remove the terminal from the connector block.

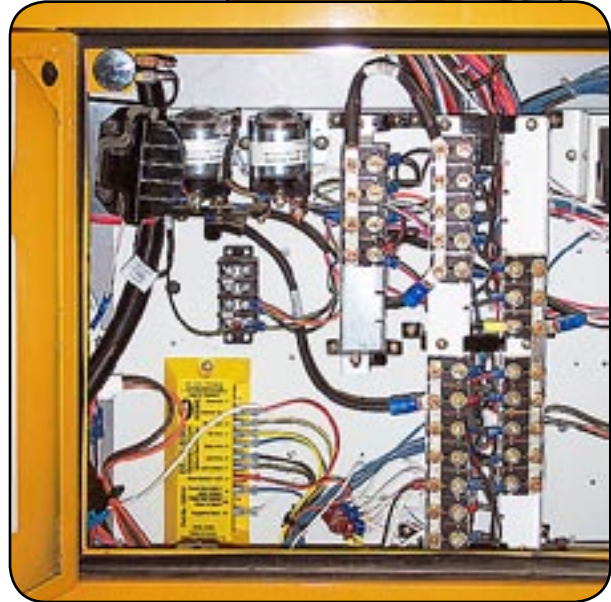
Finished modification.
