**BLUE BIRD**

**R08MX**

**SUBJECT: RECALL R08MX NON-COMPLIANT LED TURN SIGNAL FLASH RATE**

## NON-COMPLIANT LED TURN SIGNAL FLASH RATE

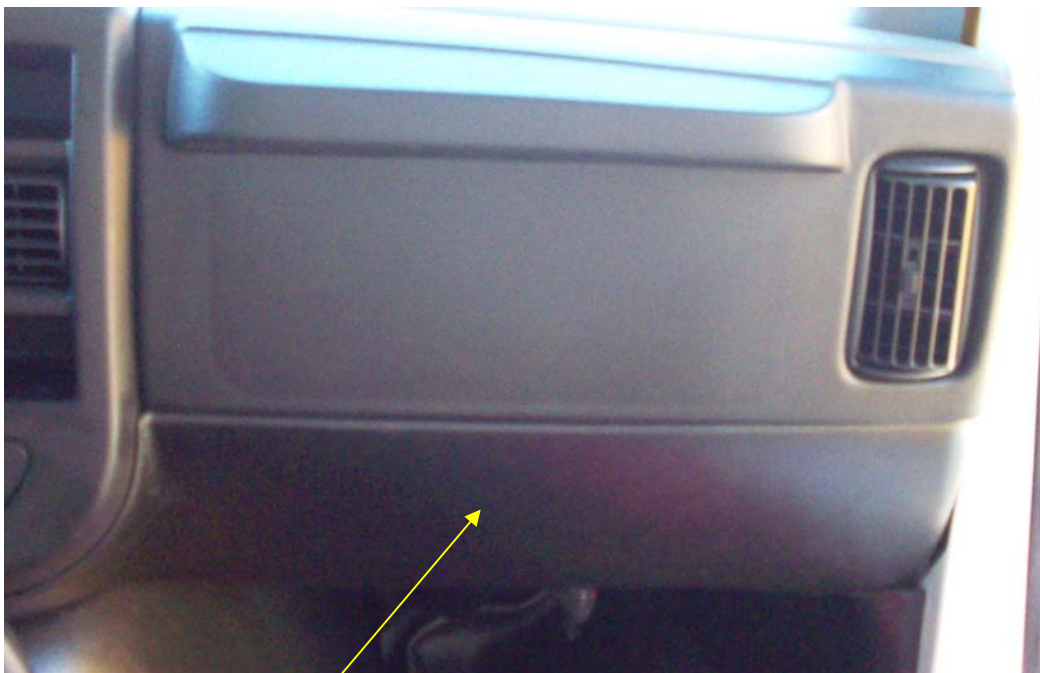
*Lower Dash Panel*

Remove dash cover on the right side of the interior above stepwell to access the body control module area.

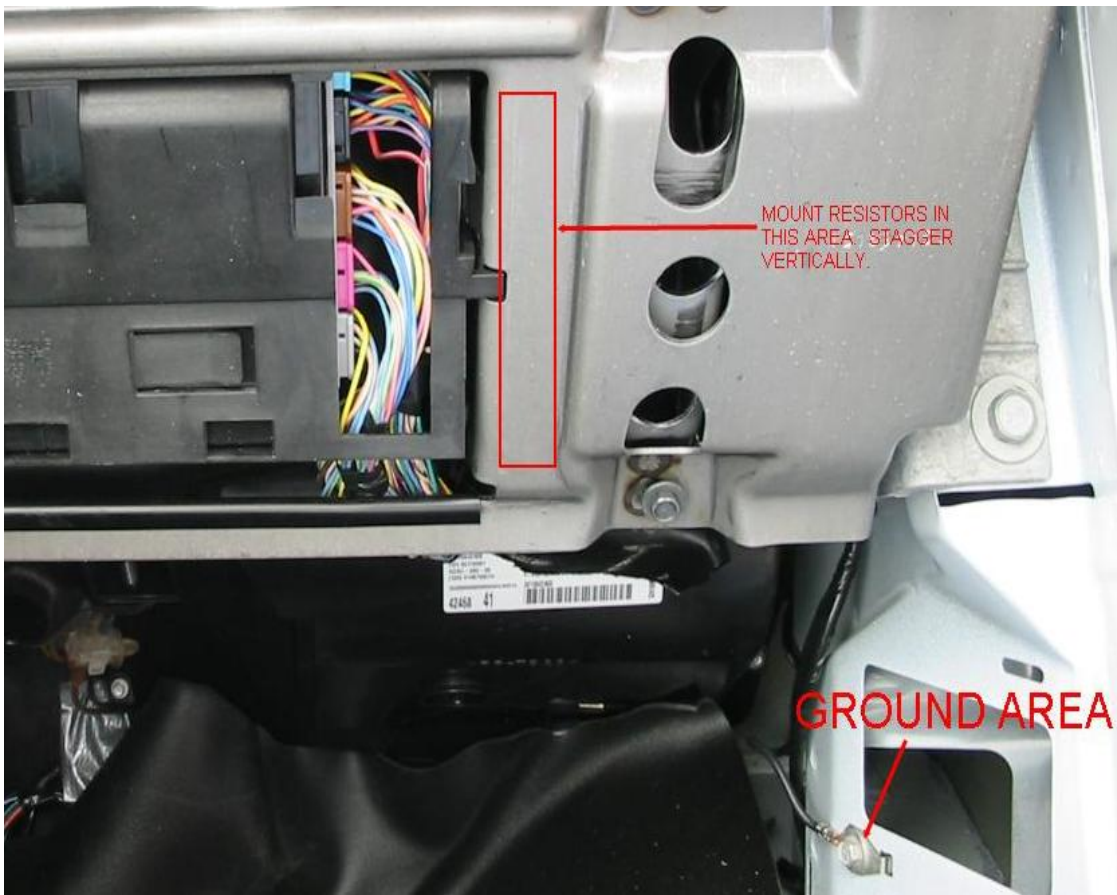
Mount the resistor in the flat area on right side of lower dash panel.

**Note: The resistor will become hot and must be mounted flush against the metal to assist in dissipating heat.**

Using resistor as a guide, mark and drill .125 holes in the location and secure with screws, part number 0527267, provided in kit. Use proper drill stop to prevent damage to components located behind the metal enclosure.

Locate Yellow wire (Pin 1) and Dark Green wire (Pin 2) from the X5 connector (Brown) of the Body Control Module.

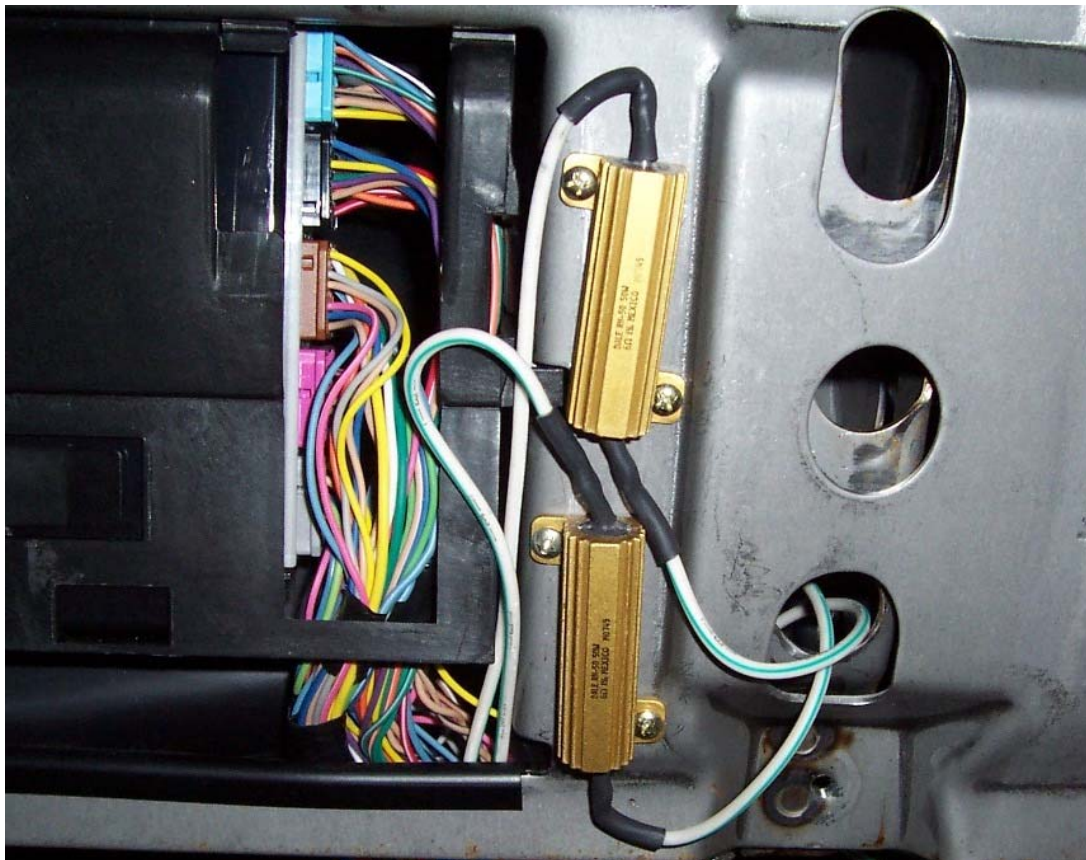
Locate circuit 618 (yellow wire) and cut wire and splice one flasher resistor harness into circuit 618.

Splice the second flasher resistor harness into circuit 619 (dark green wire) using the same procedure.

**Circuit 618 is yellow wire in Pin 1 on brown connector.**

Strip 3/8" of insulation from both ends. Twist the two ends together and insert into the butt connect provided on the end of the resistor harness and crimp.

Using a heat gun, shrink the plastic wrap over the connector and end of wires.

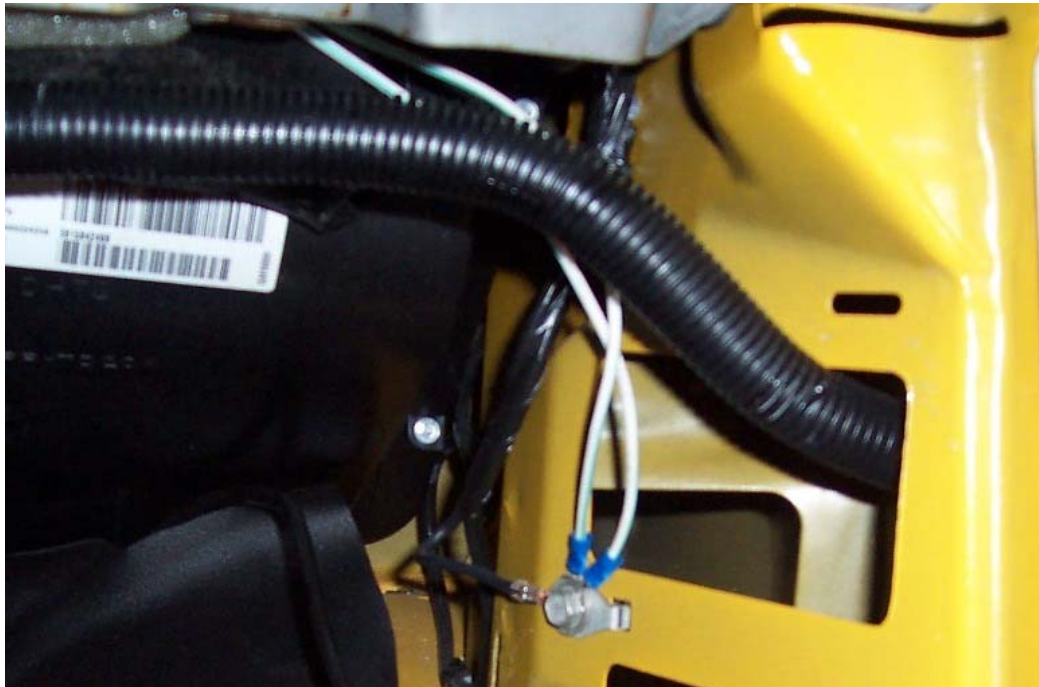
Run the loomed ground wires to the bottom right hand kick panel area.

Resistor harness must be grounded along with the antenna lead.

**Ground wire location (shown without loom for illustration only)**
