**SUBJECT: SERVICE BULLETIN S07LU C.E. WHITE CHILD RESTRAINT
TRACK MOUNTED SEATS WALL ATTACHING BRACKET**

**AFFECTED: CERTAIN 2006 MODEL YEAR ALL AMERICAN FRONT ENGINE
BUSES**

Seat Mounting Bracket

S07LU

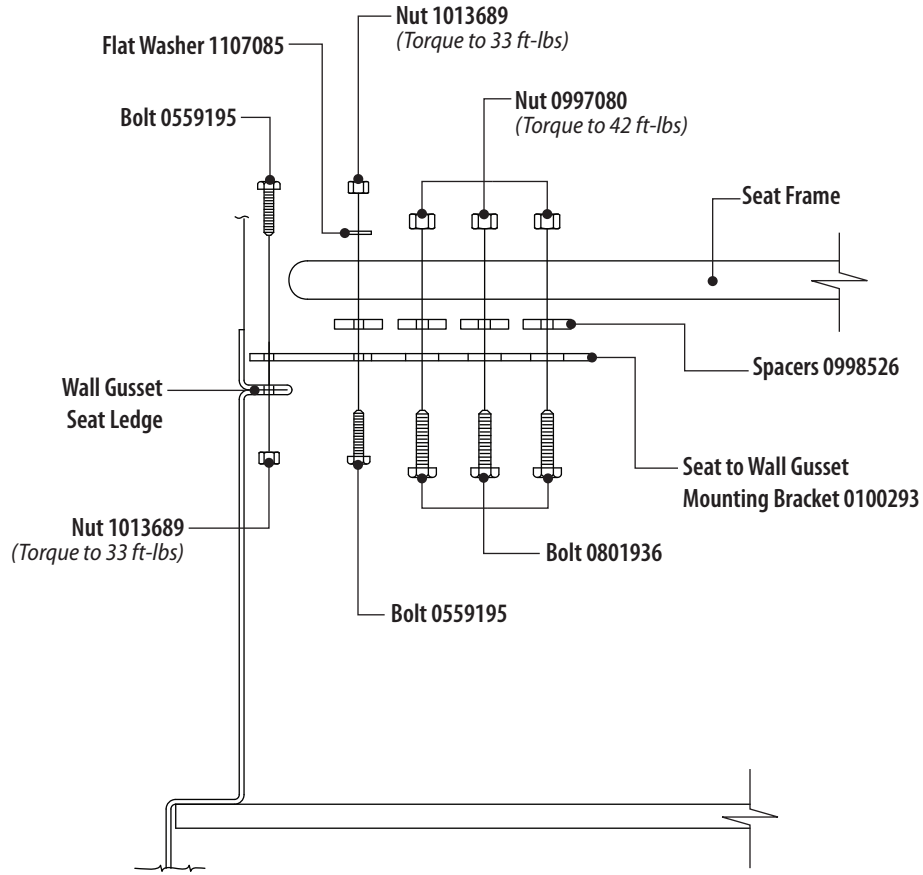
The seat to wall gusset mounting bracket on CE White Child Restraint track mounted seats located above the front wheelhousing may crack and break.

- 1** Park vehicle on a level surface, apply parking brake, turn engine off and remove ignition key.
- 2** Remove seat cushion.
- 3** Remove and discard seat to wall gusset mounting bracket and all attaching hardware.
- 4** Attach the new bracket 0100293 to seat frame with fasteners and spacers, per diagram on page 2.

- 5** Place the seat and bracket on top of wall gusset seat ledge. Using the new bracket as a guide, drill three (3) 13/32" diameter holes. Attach bracket to gusset seat ledge per diagram, page 2.
