SUBJECT: SERVICE BULLETIN S07LZ PDU CLOSEOUT FASTENERS

AFFECTED: 2004-08 MODEL YEAR VISION (BBCV) BUSES

PDU Closeout Fasteners

S07LZ

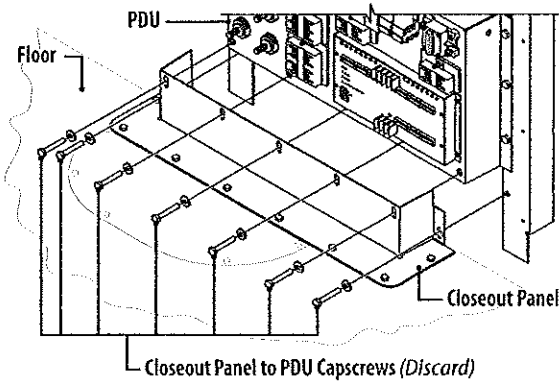
The fasteners used to attach the closeout panel to the Power Distribution Unit (PDU) may not be the correct length.

- 1 Park vehicle on a level surface, apply parking brake, turn engine off, and remove ignition key.
- 2 Loosen two thumb screws and remove the PDU cover.
- 3 Remove and discard seven Closeout Panel to PDU capscrews.

Remove the incorrect length fasteners and replace with the correct length fasteners.

- 4 Install seven new capscrews (0000610) with washers (2127173) provided for the Closeout Panel to the PDU.
- 5 Reinstall the PDU cover.
- 6 Return the bus to service.
