BLUE BIRD

**SUBJECT: SERVICE BULLETIN S07MU POWER STEERING RESERVOIR
CAP**

AFFECTED: 2008 MODEL YEAR VISION (BBCV) BUSES

Power Steering Reservoir Cap

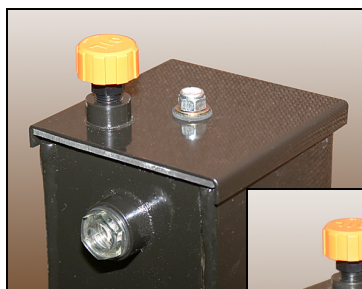
Old Design

Power Steering Reservoir Cap allows fluid leak.

Replace the existing reservoir cap with the newly designed reservoir cap.
