**R02GE**

**RECALL R02GE  
GRID HEATER WIRING MODIFICATION**

**2002-2003 ALL AMERICAN AND COMMERCIAL SERIES BUSES  
WITH  
CUMMINS ISB REAR ENGINE**

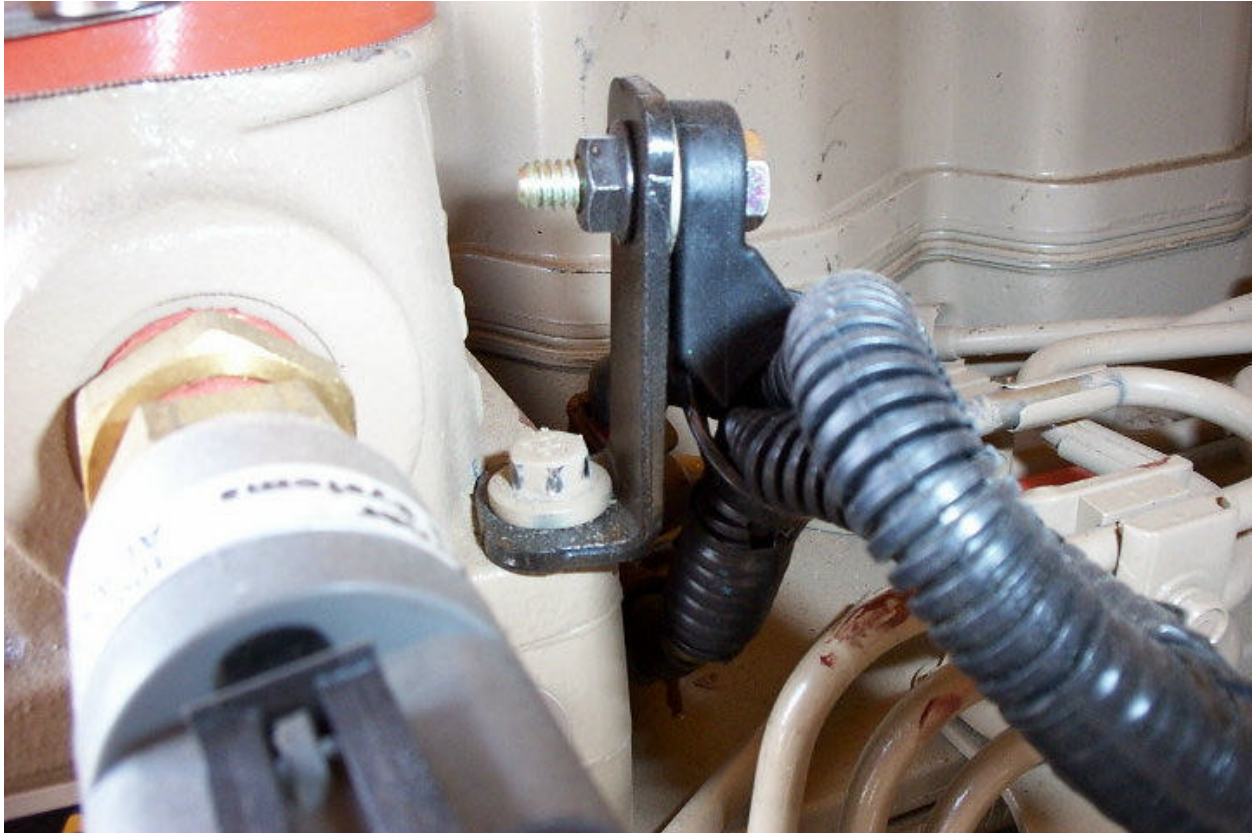
The defect involves the wiring harness for the combustion air intake grid heater on the subject buses. The grid heater wiring harness may rest against the engine or engine components and chafe through the wiring harness protective loom.

3. Remove Cummins bolt on left-hand rear of turbo inlet.
4. Install bracket (#0006378) in the direction shown in Figure 1 using the Cummins bolt and torque to 18 ft. lb. Attach mount (#0024168) to bracket with bolt (#0870477), flat washer (#1247709), and nut (#0659979) as shown in Figure 1. Install tie cable (#0029998) through the hole in the mount. Lift grid heater wires up to the new mount to provide clearance between the grid heater wires and the Cummins fuel injector lines. Wrap tie cable around grid heater wires and pull tie cable tight. Cut off excess tie cable.
