R02GP

**Recall R02GP
Throttle Position Sensor Date Code
Inspection Sheet**

Electronic Foot Pedal Caterpillar Throttle Sensor Replacement Instructions

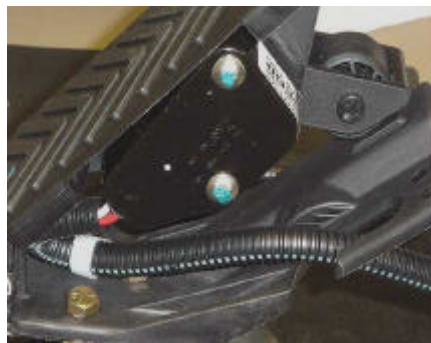
You must have the Felsted electronic accelerator pedal inspected for defective throttle position sensors. Defective throttle position sensors will have date codes from FE111 through FJ161. The throttle position sensor date codes on each of your buses must be recorded on the attached sheet and returned to Blue Bird in the pink postage paid reply envelope. Date code is located on white decal on forward side of throttle position sensor.

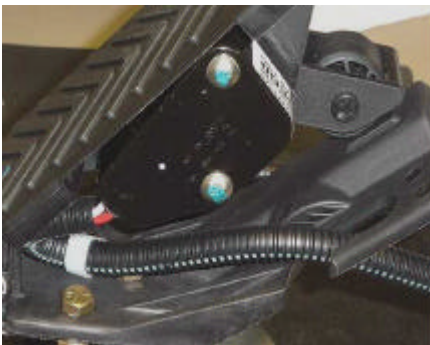
Fig. 1

1. Please read and understand installation procedure before beginning.
2. Park bus on level surface, apply parking brake, shift transmission to neutral, turn engine off, and remove ignition key.
3. Locate Electronic Foot Pedal and remove the two sensor screws, washers and sensor from the pedal. (Fig. 1)
4. Remove harness P-clips. (Save for later use) (Fig. 2)
5. Disconnect harness electrical connector. (Fig. 3)
